**Field Evaluation and Analysis of Automated Rut Measurement Systems
Data for Texas Conditions**

Thesis

The University of Texas at Austin

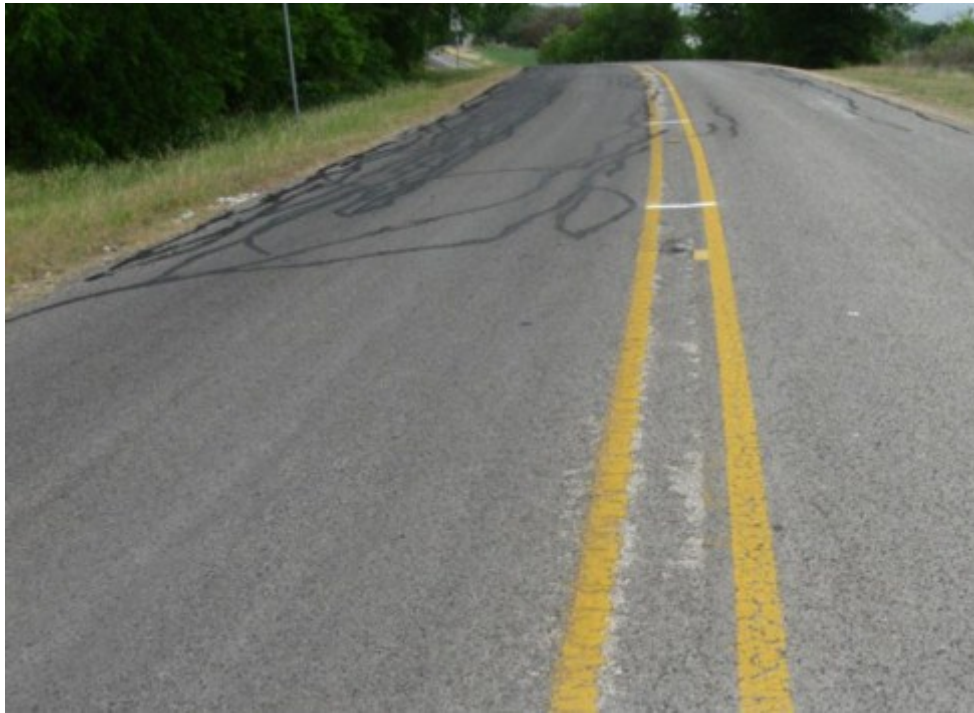
Figure 3.29: Section 25: FM 112-2.

- Surface texture type: Coarse.
- Lane width: Irregular, between 10.0ft to 12.0ft.
- Shoulder: No paved shoulder.
- Horizontal curve: Sharp right curve.
- Vertical curve: Uphill.
- Observed pavement distresses: Presence of several sealed cracks.
- Additional comments: Adjacent to Section 26 (as shown in Figure 3.29). Presence of crest vertical curve.

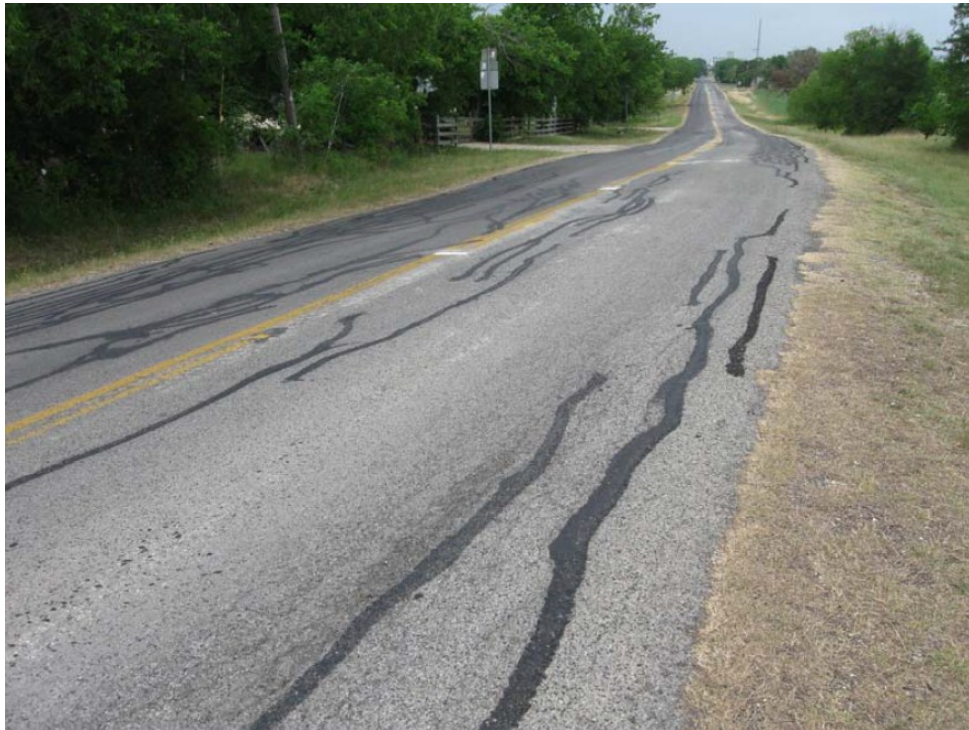
Figure 3.30: Section 26: FM 112-3.

- Surface texture type: Coarse.
- Lane width: Irregular, between 10.5ft to 11.5ft.
- Shoulder: No paved shoulder.
- Horizontal curve: Sharp left curve.
- Vertical curve: Downhill.
- Observed pavement distresses: Presence of several sealed cracks.
- Additional comments: Adjacent to Section 26 (as shown in Figure 3.30). Presence of crest vertical curve.

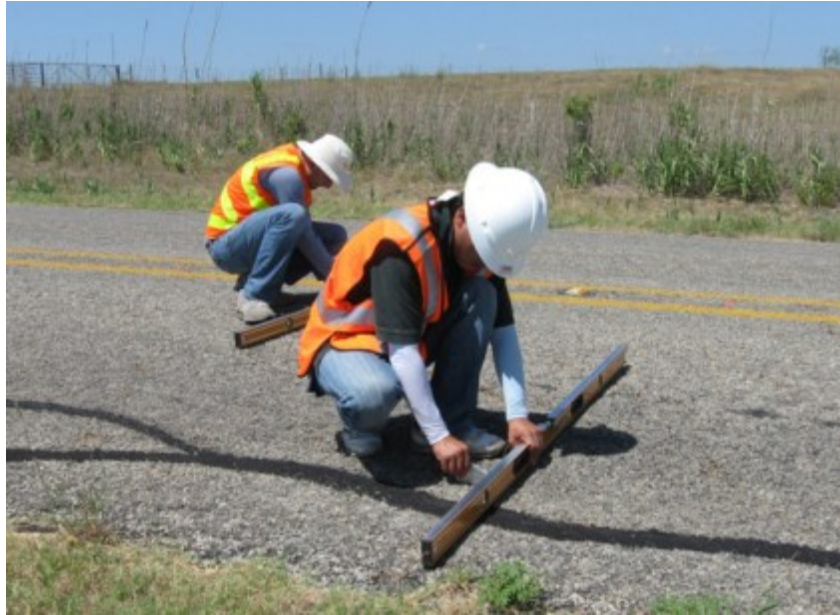
Figure 3.31: Manual measurement of MRD.

Four raters performed more than 95% of the manual MRD measurements; two additional raters collected the remaining 5%. Figure 3.31 shows one rater per wheel-path manually measuring the MRD values at Section 24. As shown in the picture, in the majority of cases, the raters did not take the MRD measurements at the same station in the same moment in order to have enough free space available at the sides to laterally move the straightedge when looking for the MRD value. A third person recorded the readings being collected by the raters in a spreadsheet prepared for the experiment.

The MRD values for both the IWP and the OWP were measured using a 6-ft straight-edge and a gage. The procedure adopted for the measurement of the MRD is the one described in the ASTM standard “*E1703/E1703M – 10: Standard Test Method for Measuring Rut-Depth of Pavement Surfaces Using a Straightedge*”. The procedure consisted of placing the straight-edge on the pavement perpendicular to the direction of traffic, and measuring the maximum distance between the pavement surface and the bottom of the straight-edge, taken perpendicularly to the straight-edge. In order to find the MRD of the wheel-path, the straight-edge was moved laterally to both sides and the depth was measured at different locations between the two contact areas of the straight-edge and the pavement surface, until the maximum depth was found.

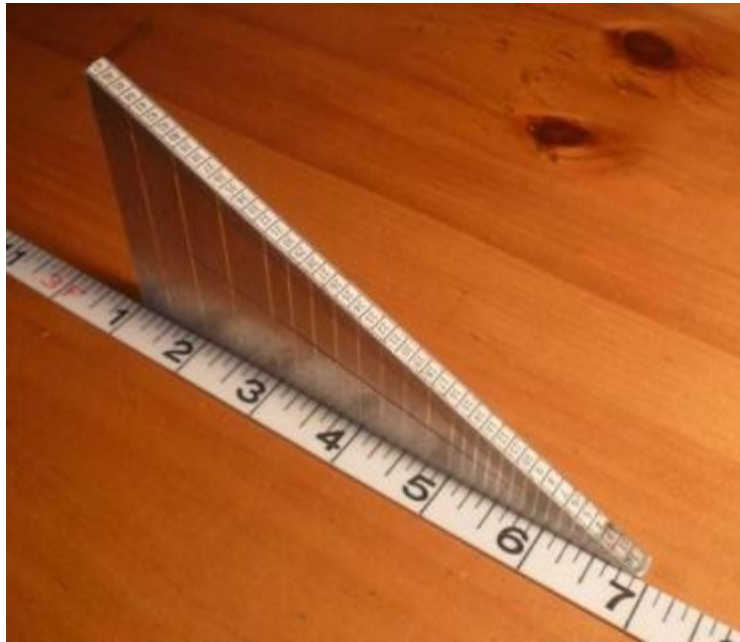
Figure 3.33: Rut wedge length.

The two measuring gages used in the study consisted of 6in long, 0.25in wide and 3in high aluminum wedges, graduated to $\frac{1}{16}$ th of an inch. Figure 3.33 and Figure 3.34 show a picture of the length and the width of the rut wedges, respectively. The adopted standard specifies a minimum of 0.75in for the width of the rut wedge in order to span areas of aggregate loss and texture. Although the wedges used in the study are narrower than the minimum width specified, their length made them long enough to span the aggregates and therefore, considered acceptable by the research team.

When the reading from the rut wedge was in between two marks, the value was rounded up. Thus, if a reading was in between the $\frac{8}{16}$ in and $\frac{9}{16}$ in marks, the reported value was $\frac{9}{16}$ in.

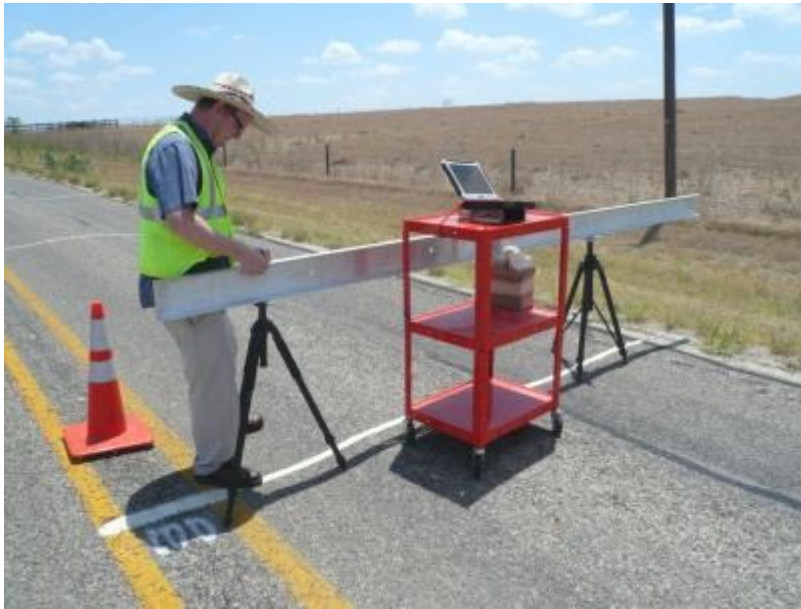
Figure 3.35: Leica Laser System for the measurement of transverse profiles.

One transverse profile was collected every 25-ft, for a total of 23 profiles (stations) per pavement section. Figure 3.35 shows the set-up of the system used for measuring the coordinates of the transverse profiles and Figure 3.36 shows a close-up picture of the laser distance meter used. The system developed for this study (referred to by the researchers as the “Leica System”) included:

- Laser distance meter Leica DISTO D8 with a reported accuracy of $\pm 1.0\text{mm}$ [Leica Geosystems DISTO D8 Specifications];
- a 13.5ft long 6061-T6 aluminum structural channel beam C6”x1.92”x0.2”;
- two tripods (one geared);
- a Mitutoyo 960-616 precision level with a 0.00024"/12" Sensitivity and $\pm 0.00017"$ accuracy [Mitutoyo, Small Tool Instruments and Data Management Specifications];
- and the data acquisition system which consisted of a Panasonic Toughbook computer connected with the laser distance meter through a Bluetooth connection.

The beam was graduated in 6in increments along the top from 0 to 144in with two additional marks at -3in and 147in, comprising a total of 27 marks covering a maximum measuring width of 150in.

The procedure for the collection of coordinates for each transverse profile consisted of placing 2in wide masking tape transversally along the lane width, then,

positioning and leveling the beam, and, finally, taking the readings. The masking tape was placed to bridge cracks and coarse aggregate macro-texture which might introduce error for the MRD calculation. The positioning of the beam consisted of moving the beam until the laser light projected vertically from the zero mark of the beam to the center of the center line paint stripe closest to the test section. Once the zero mark was aligned with this stripe, the laser light was projected at different points along the beam to check that the C beam was correctly placed over the surface of the tape. The position of the beam was corrected as necessary. The leveling of the beam was done to ensure the same reference plane for all the transverse profiles. The precision level was centered on the top of the beam and the height of the outer tripod was adjusted until the beam was leveled. Once set up was completed and checked, the Leica D8 was used to measure, the distance between the top of the beam and the pavement surface at each mark on the beam. The mark on the beam was determined as the “x” coordinate and the reading from the laser distance meter was the “z” coordinate for each profile point. As shown in Figure 3.35 and 3.36, the operator placed the laser distance meter in the “x” coordinate being measured and the laser was set to take automatic readings every 4 seconds. If the beam projected beyond the end of the pavement and a reading was therefore outside the lane width, it was not collected. As an example, Figure 3.37 shows the collected coordinates (red points) in inches of the transverse profile of a particular station on FM1063. The origin of the coordinates ($x = 0$, $z = 0$) was placed at the center of the inner stripe. Therefore, the “z” coordinates of all the points are relative to the “z” reading at $x=0$ (second point).

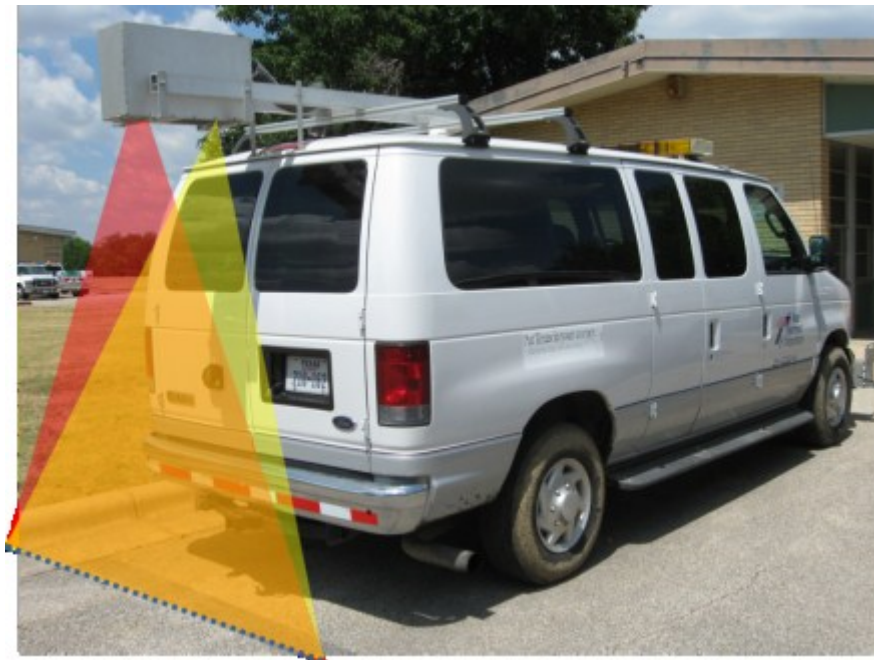
Figure 3.38: TxDOT' system for the automated measurement of rutting.

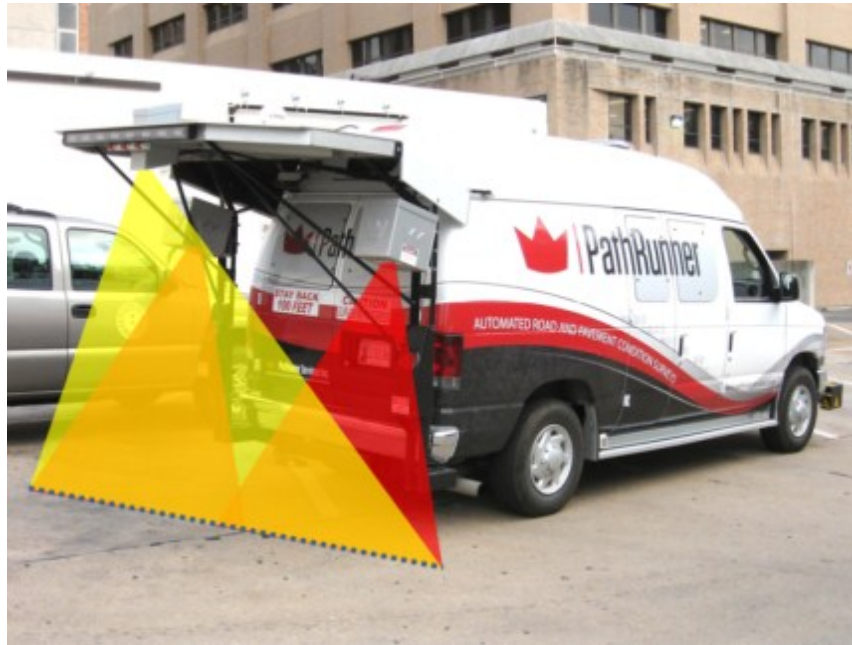
Figure 3.39: Pathway' system for the automated measurement of rutting.

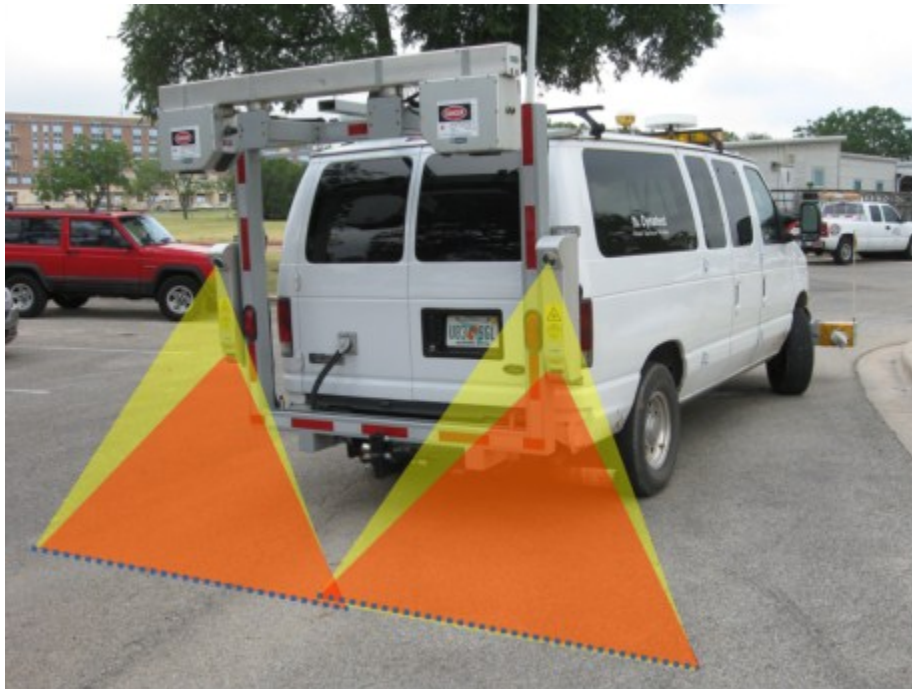
Figure 3.40: Dynatest' system for the automated measurement of rutting.

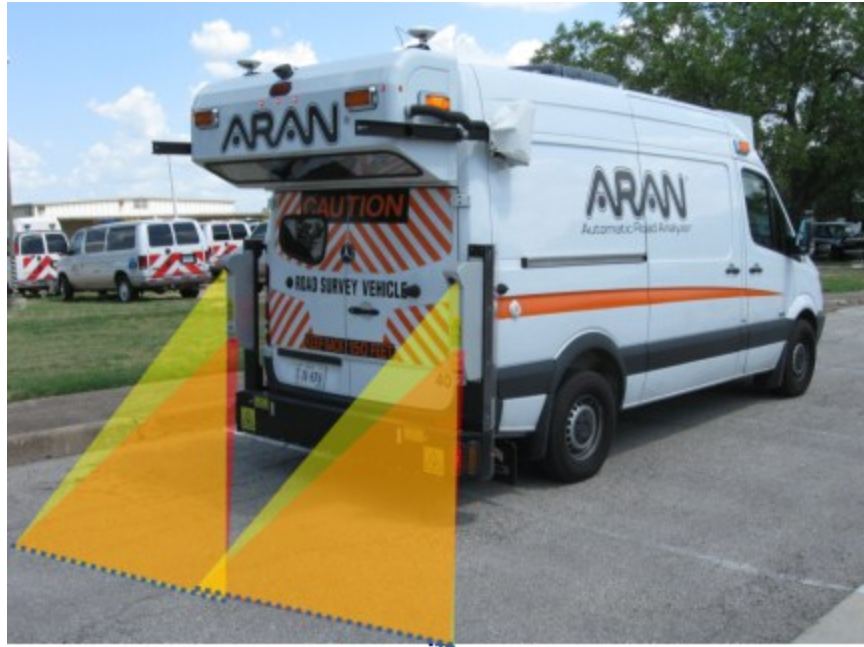
Figure 3.41: Roadware' system for the automated measurement of rutting.

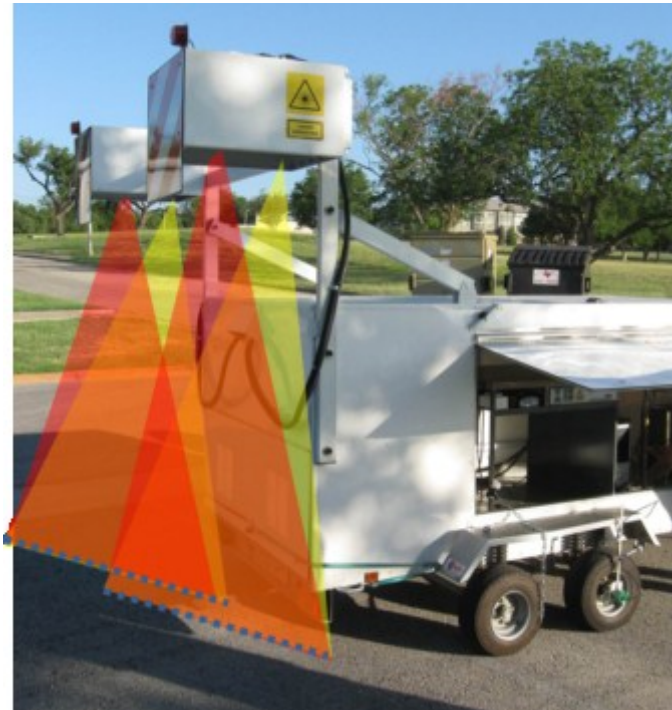
Figure 3.42: Applus' system for the automated measurement of rutting.

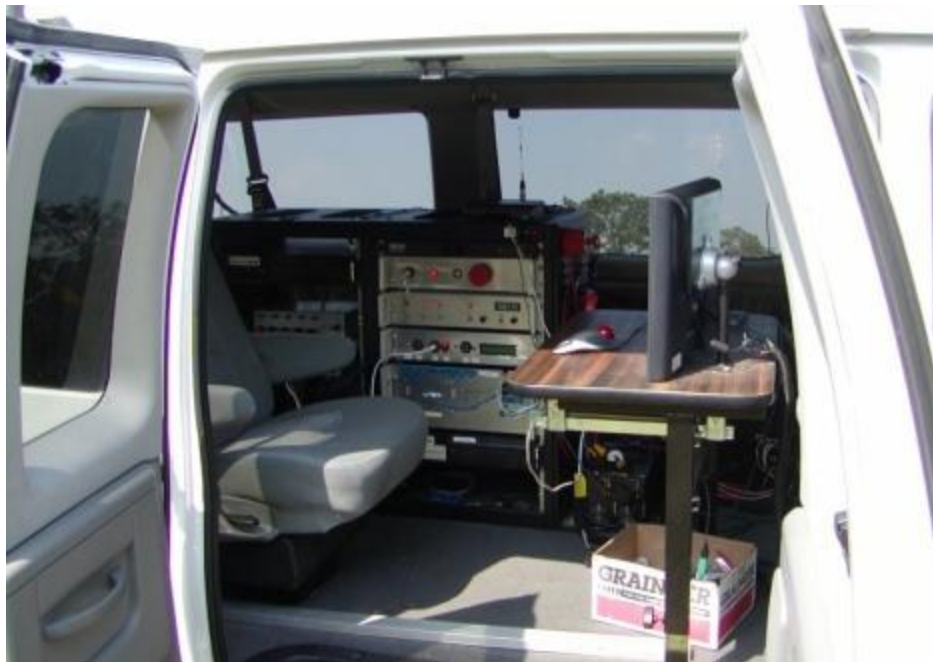
Figure 3.43: TxDOT system's control unit.
